Hilti CFS-C EL Firestop Collar Endless

Submission Folder			
Product Information and Method Statement	2		
Test Reports			
RED No. R16L28-1C	7		
RED No. R18F14-2A	38		
VOC Content	94		
Letters			
Government Letters	95		
Country of Origin	98		
Non-CFC and Ozone Confirmation	99		
Material Information Statement 100			
Job Reference 101

Firestop collar endless CFS-C EL NEW

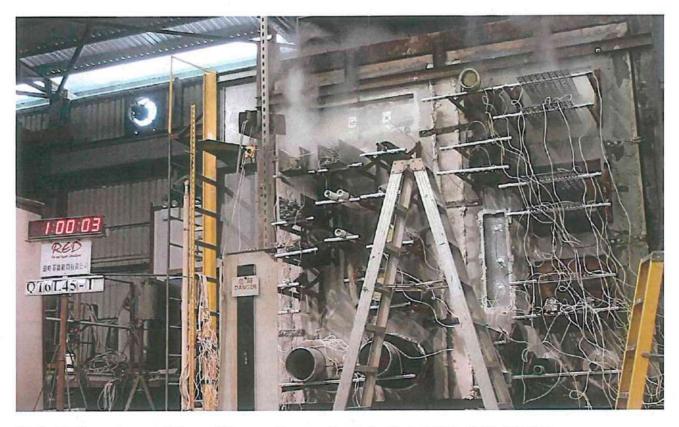
Photo 3: The unexposed face of the specimens after a heating period of 60 minutes.

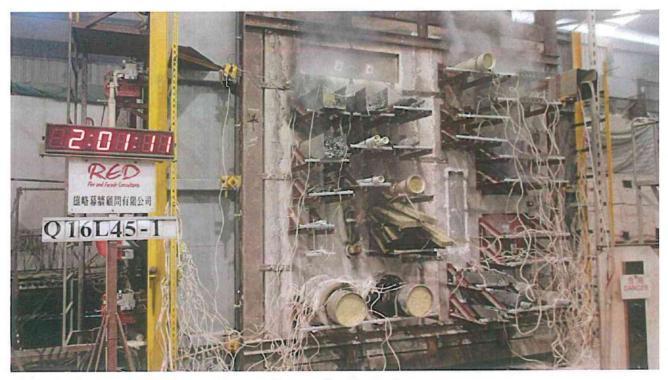
Photo 5: The unexposed face of the specimens after the test.

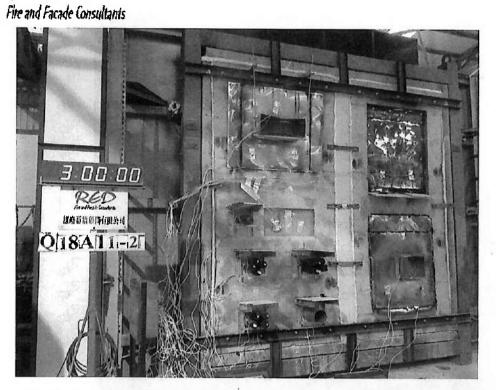
Photo 5: The unexposed face of the specimens after a heating period of 180 minutes.

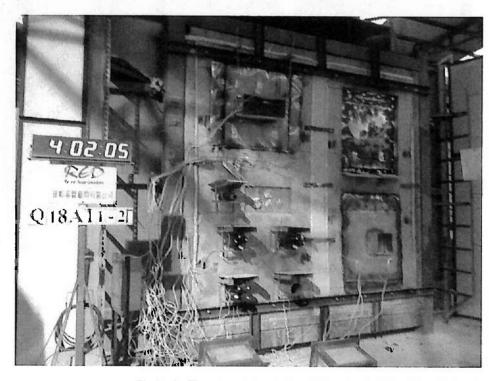
Photo 6: The unexposed face of the specimens after the test.
